APTOS CREEK FISHERIES HABITAT ASSESSMENT

Technical Memorandum

Prepared for: **Coastal Watershed Council**

APTOS CREEK WATERSHED ASSESSMENT AND ENHANCEMENT PLAN: SALMONID HABITAT AND LIMITING FACTORS ASSESSMENT

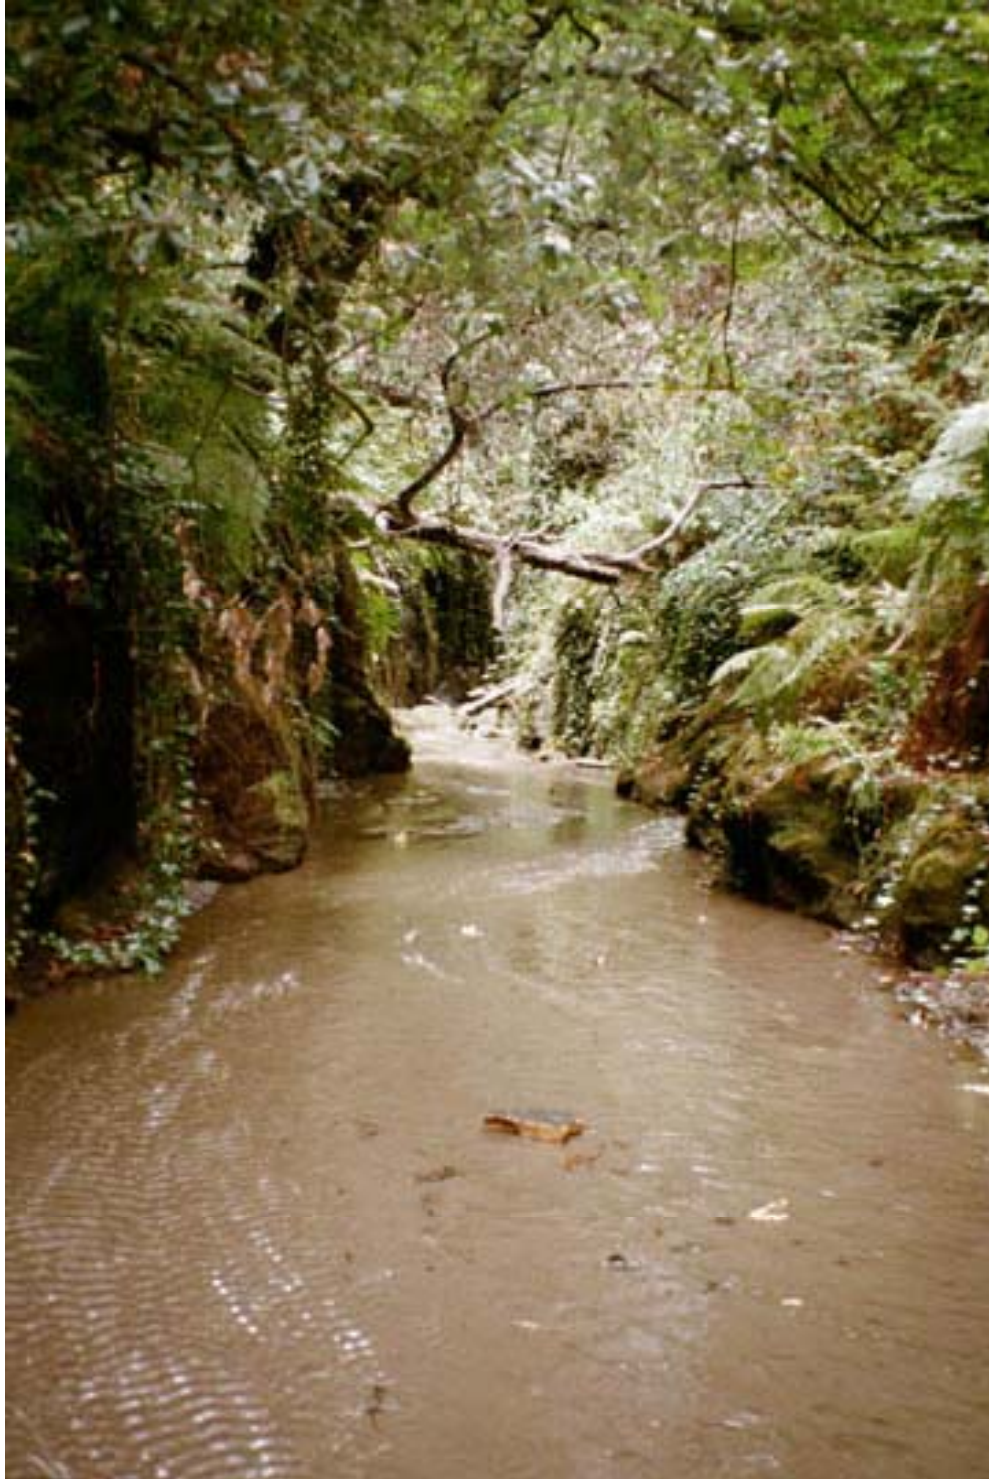
Figure 12. Riffle/Glide Habitat in Valencia Creek

Valencia Creek was even more heavily influenced by sand than Aptos Creek (Figure 12). Sand was the dominant substrate in 100% of habitat units in the two lower reaches (Aptos Creek to Valencia Road). Sand was also dominant in 94% of the habitat units in reach 3 (upstream of Valencia Road). As a result, there were no pools in reaches 1 and 2 and pools made up slightly less than 1% of the length of reach 3. Gravel and cobble substrate were present as dominant substrates only in reach 3, where these classes were dominant in 6% of all units and 20% of riffle units. Even in reach 3 of Valencia Creek, sand was either dominant or subdominant in 80% of the habitat units.

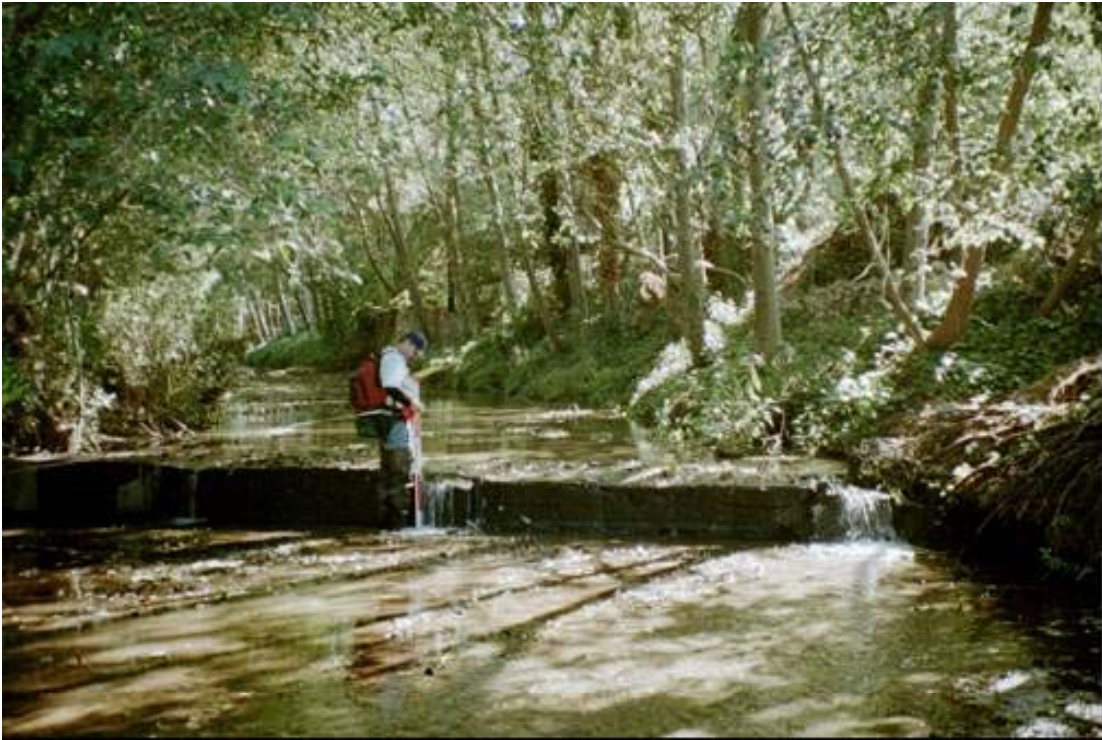
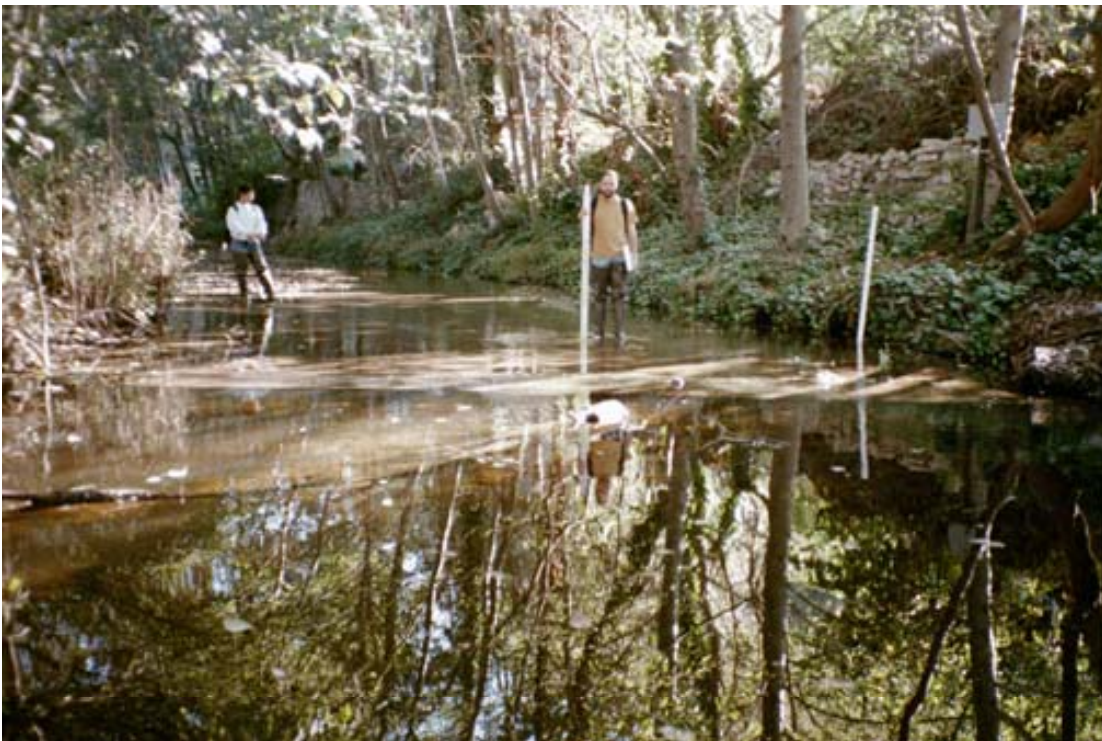
Figure 16. Weir at Spreckels Road

There are no significant obstacles to migration of adult steelhead and coho salmon in the lower five reaches of Aptos Creek, although there are three locations where adult upstream migration may be impaired at lower levels of flow (Table 10, Figure 15). The first of these is immediately upstream of Spreckels Road and consists of a concrete weir spanning the creek (Figure 16). At the time of the survey the weir rose about 1.5 feet above the downstream water surface with a relatively shallow depth of flow up to about 1 foot deep immediately downstream of the weir. It is expected that the loose sand substrate would be scoured out from below the weir at higher flows, forming a deeper pool from which fish could leap over the weir. This condition was observed on December 12, 2001 when a pool up to 4 feet deep had been scoured below the weir. In addition, observations on October 1, 2001 indicated that at higher lagoon stages (0.85 on SH&G lagoon staff gage), the water surface backs up over the weir and eliminates any barrier effect (photos available). Upstream of the weir the sandy channel is wide and uniformly shallow for a long distance upstream (a few hundred feet).

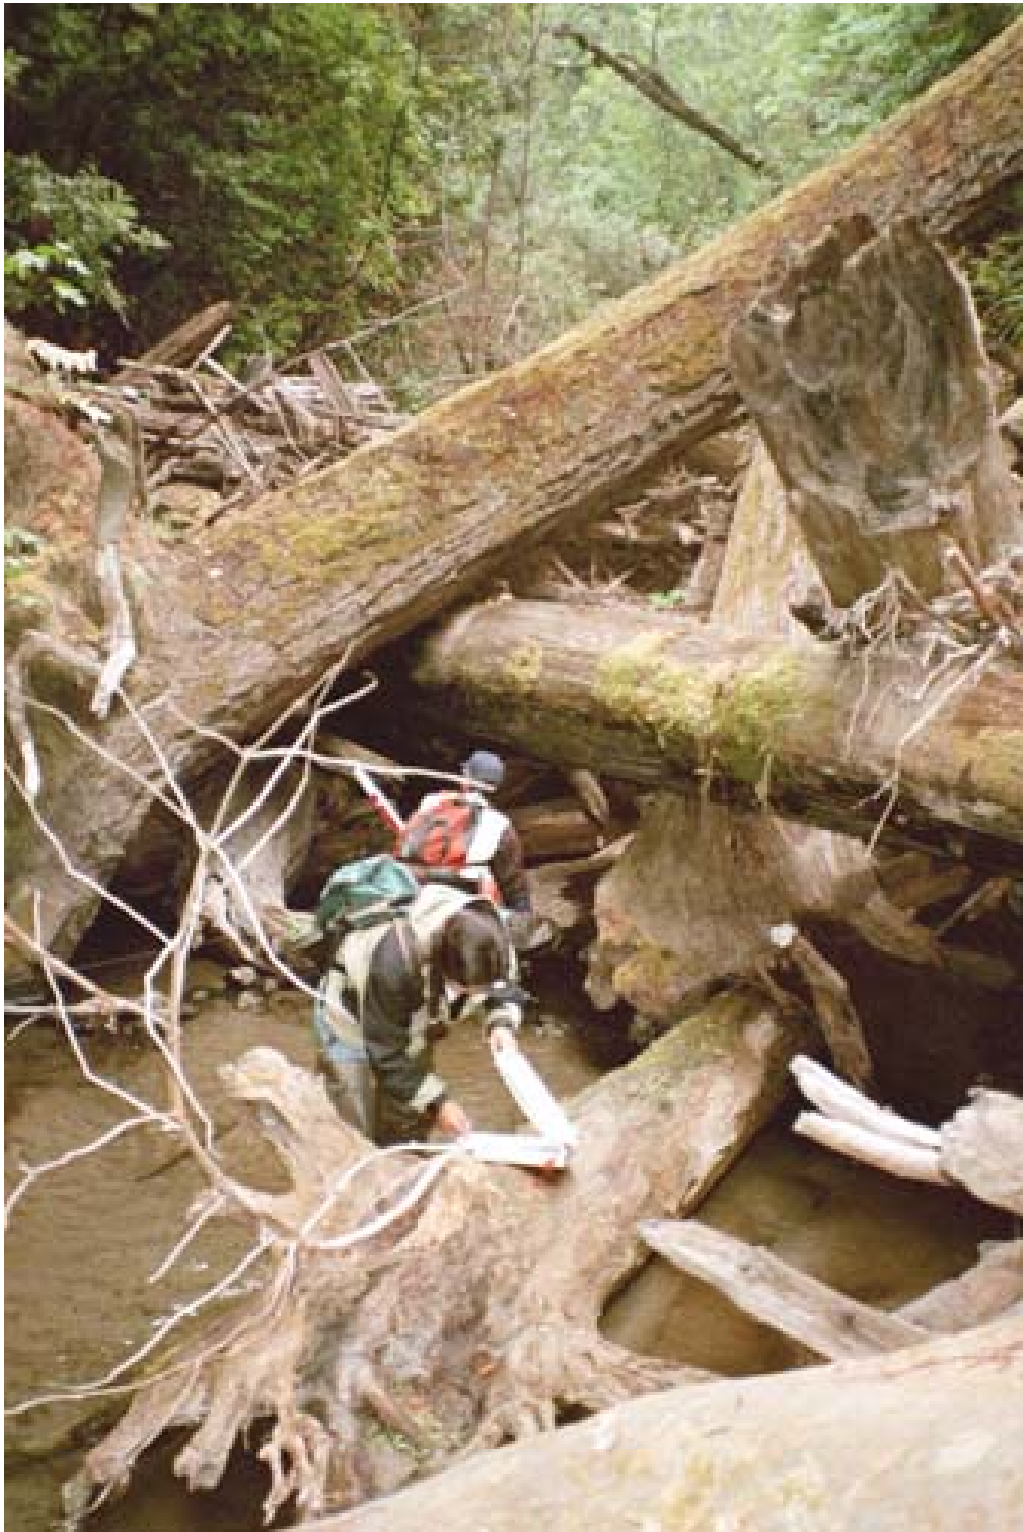
Figure 17. Large Debris Accumulation (LDA), Upper Aptos Creek

The other two locations in Aptos Creek, reaches 1-5, where adult passage may be impaired are caused by accumulations of large woody debris (LDAs) and these did not appear to present significant obstacles to passage of healthy adult steelhead or coho. The first had an elevation change of only about 2.5 feet and at higher flows this would be reduced. An unobstructed side channel was also available that would likely provide passage at higher flows. The second LDA had a more substantial elevation change of about 5.5 feet but there was relatively good flow under the debris and adults would likely be able to pass through the jam at moderate flows.

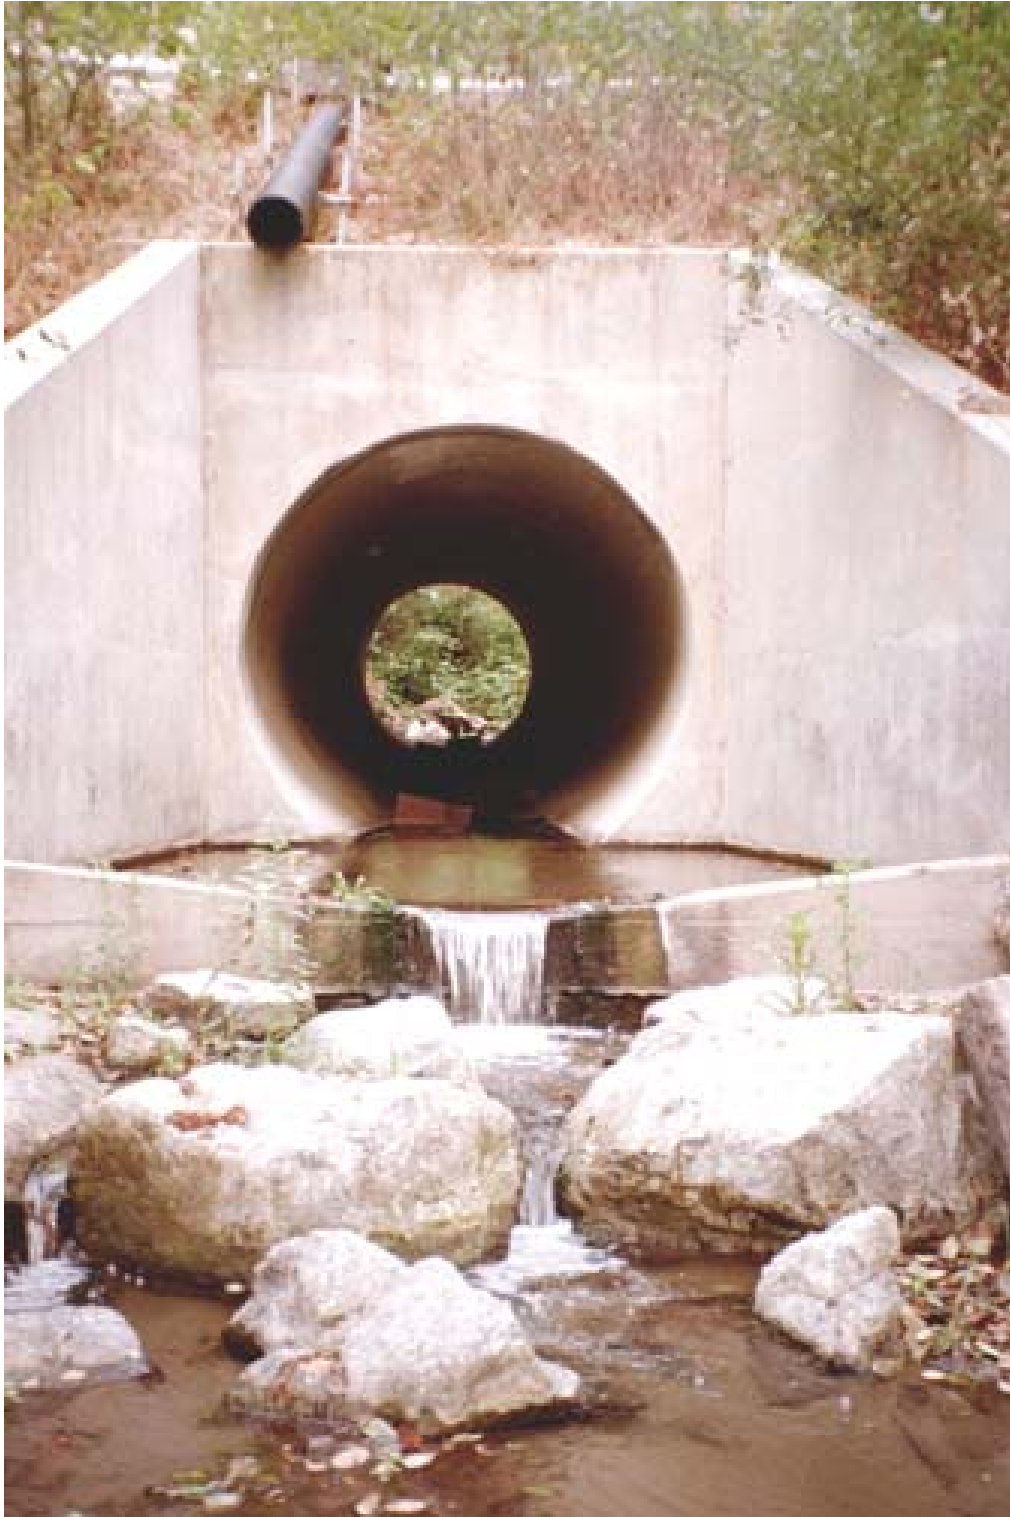
Figure 21. Fourth Valencia Creek Culvert, at Valencia Road

The seventh obstacle in Valencia Creek is the culvert at Valencia Road, approximately 3.4 miles upstream from the Aptos Creek confluence (Figure 21). Although fitted with baffles to improve the potential for migration, the culvert is quite steep (gradient of about 4%) and the lower end is perched about 2 feet above the stream bed. Since this culvert is fairly high in the watershed, flows sufficient for passage may be relatively infrequent. The culvert was recently evaluated using FishXing analytical methods and software. Coastal Watershed Council staff observed a 6-8 inch trout enter this culvert and swim part way through it using the baffle system in early November 2002 (Maya Conrad, Coastal Watershed Council, personal communication, January 2003).
